Study of Damaged Wushi Bridge in Taiwan 921 Earthquake

By Yao T. Hsu¹ and Chung C. Fu², Members

Abstract: This paper reports on the damage of Wushi bridge in a recent Taiwan 921 earthquake. Damage to Wushi bridge appeared in the superstructure, the substructure and the approaches. Typical types of damage are discussed and illustrated in this paper. A review of the bridge design specifications in Taiwan is also presented to give the background on the seismic design of Taiwan highway bridges.

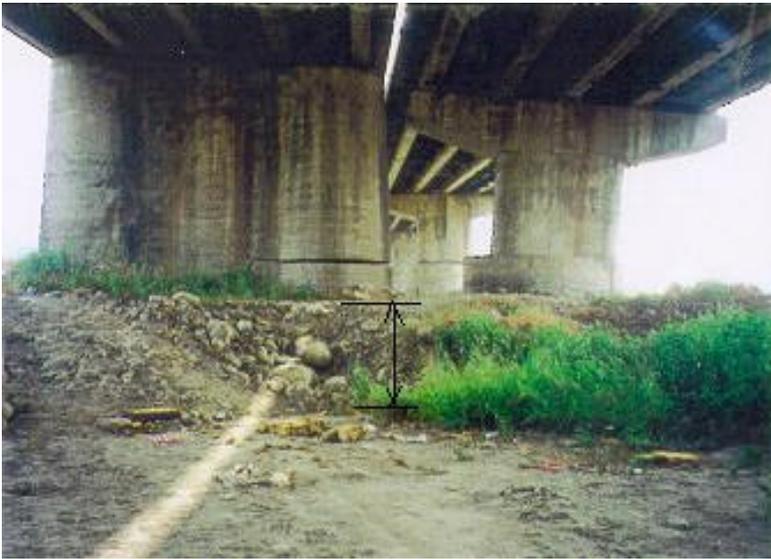
The Wushi bridge is a river crossing bridge and it incidentally crosses the Chelongpu Fault. The northern end of the bridge was the more severely damaged. One side of the fault was lifted vertically about 2.1-2.3 meters. Movement along the bridge's longitudinal direction was estimated to be about 2.2-2.3 meters and the movement along the bridge's transverse direction was about 2.1-2.3 meters. The third span of the northbound bridge crosses the subduction zone boundary with 45° reverse fault movement. The movement caused the superstructure of the first several spans to fall to the ground. Inspection (Fig. 5) showed clear evidence of fault uplifting on both sides of the fallen spans.

Figure 5 - Oblique Fault Movement between Piers P3N and P3S

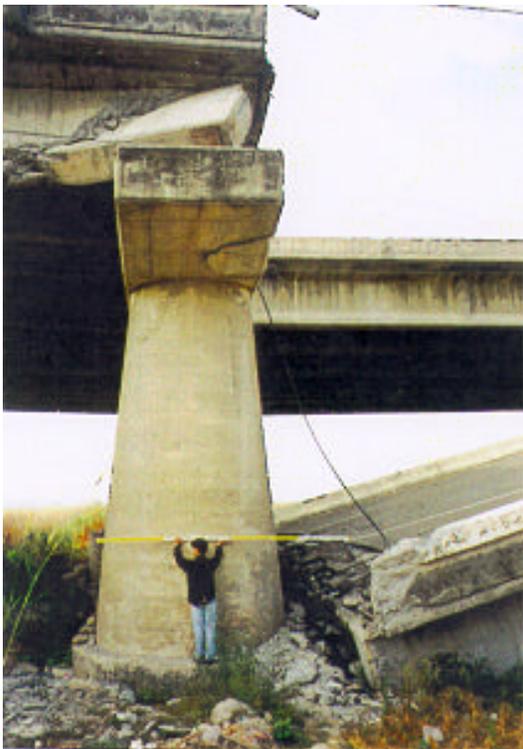
The record closest to the site was made at the Freefield Strong Seismic Station TCUD71, which is about 5.5 Km southeast of the nearest town of Chao-Fung. After the Chi-Chi earthquake, Wushi bridge was severely damaged and the road was closed. Due to the slip movement, the first and second spans of the northbound bridge fell to the ground and the third span clearly showed lateral movement (Fig. 6). The northern end abutment of the northbound bridge was pushed by the span and the jigsaw type of expansion joint and the backwall board were demolished. Under the pressure, the backfill was pushed by the superstructure and moved upward (Fig. 7). Under horizontal vibration, substantial shear cracks showed on the southbound hammerhead concrete pier (Fig. 8). The cap of the first pier of the northbound bridge (P1N) cracked and the East side exterior PCI beams were flexured. The end diaphragms and shear blocks designed to prevent concrete beams from moving laterally were crushed as the whole superstructure moved westward (Fig. 9).

collapsed with fallen beams on the first two spans. Span failure in this case was due to unseating, which includes pier tilting, insufficient seat length and inadequate restraining force capacity.

Figure 6 - Fallen Beam due to Superstructure Movement in the Longitudinal Direction at Pier P2N

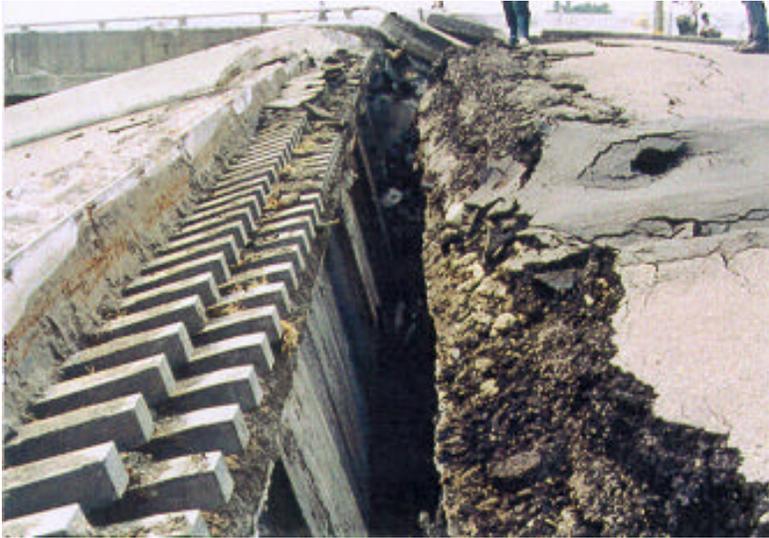
- (1) **Abutment and Wingwall Failure:** Potential slumping at bridge abutments has traditionally been ignored during design in Taiwan. As far as earthquakes are concerned, there are two types of bridge abutments: integral abutment and seat-type abutment. The essential difference is that one (seat-type) permits relative movement to occur between the superstructure and end support and the second type (integral) does not. After filling the gap between the seat and the abutment back wall in Wushi bridge, the backfill and road surface did not allow further movement. Impact of the superstructure generated high passive pressure, resulting in rotation with damage to the top and pile supporting system. The recommendation for minimizing the drop of the road elevation is to be able to install approach slabs. Simple span reinforced concrete slabs can be designed with a minimum length of 3 meters for the approach slab. Figure 7 shows clearly the back-fill settlement. It has also been learned that abutment back-wall, back-fill and approach slabs should be carefully designed and constructed to prevent collapse.

Figure 7 - Backfill Upward Movement at the North Abutment of the Northbound Bridge

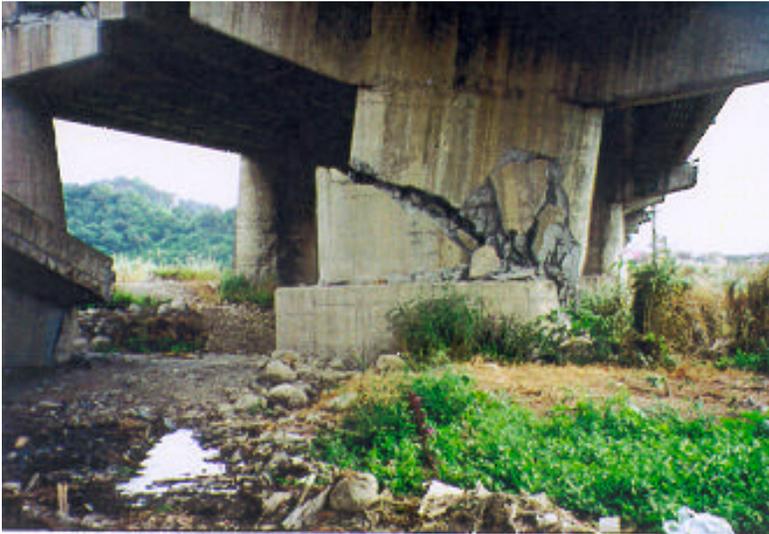
- (2) **Substructure damage:** Wall piers and hammerhead single column piers are used in substructures on north- and southbound, respectively. It is well known that it is economically feasible to design columns to yield and dissipate significant amounts of energy and to perform in a ductile manner. However, with relatively short columns and much stiffness in the transverse direction, shear cracks appeared on piers P1S, P2S, P3S, P5S, P7S, P8S. Typical shear crack shows in Figure 8. Shaft foundation was used in Wushi bridge to support piers. Since the fault line crosses between piers 2 and 3, parts of the foundation, especially ones close to the fault line, were severely damaged and some settled (Fig. 10).

Figure 8 - Shear Cracks on the Southbound Hammerhead Concrete Pier p2S

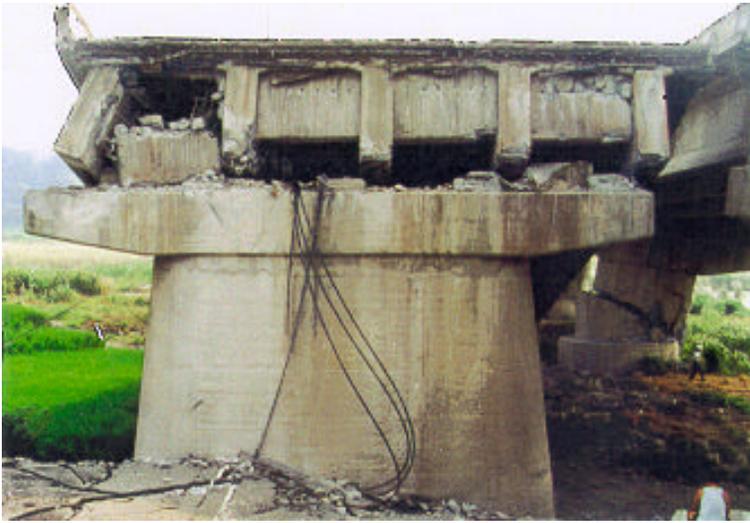
- (3) **Superstructure Failure:** The main reason for the severe superstructure failure was the major fault movement in the horizontal and vertical directions. Since the fault line intersects the bridge at 45 degrees, the superstructure pushed and pulled in the longitudinal direction and, in the mean time, impacted upon the shear blocks in the transverse direction. Due to large movements, the bridge

Figure 9 - Crushed End Diaphragms and Shear Blocks at Pier P1N

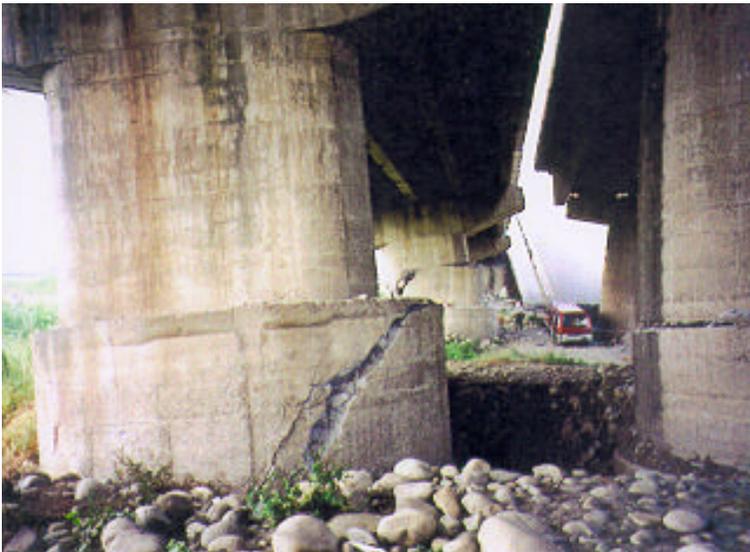
Figure 10 - Pier Settlement and Shaft Shear Cracks at Pier P3N
