## BODIAM CASTLE: A NEW SURVEY OF THE INTERIOR

**Abstract.** This chapter discusses the form and interpretation of the internal layout of Bodiam Castle, East Sussex, England. It first reviews previous work before presenting new plans based on a detailed total station survey of the castle interior. The interpretation of the internal form of the castle is reassessed in the light of this new plan. We draw attention to the evidence for changes of mind and other inconsistencies behind what at first sight is a very regular layout. We go on to discuss the implications of Bodiam for wider interpretation of later medieval domestic spaces.

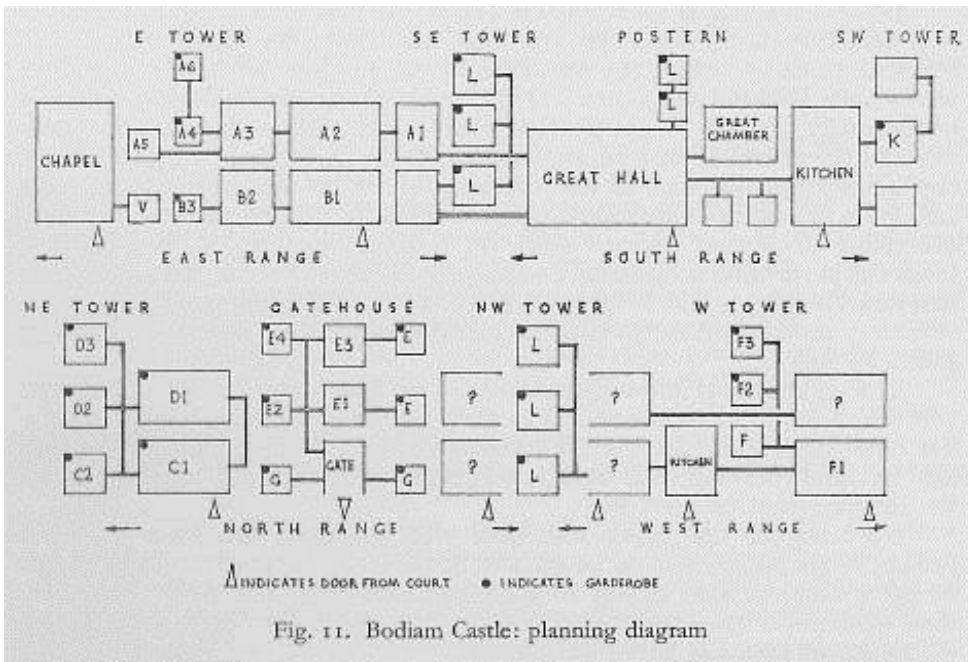
Fig. 3.2: Faulkner's access diagram (after Faulkner 1963, fig. 11).

In the 1960s, Patrick Faulkner also used Bodiam as a case study in a wider argument. In a seminal article, Faulkner used an early form of access diagram to illustrate the evolution of domestic planning in larger medieval buildings between the 12th and the 14th centuries (Faulkner 1963; Johnson 2012b; see Fig. 3.2). Faulkner pointed to the number and importance of lodgings in the later middle ages and talked of the multiple-household arrangement at Bolton, Bodiam and other buildings. We will look at the 'lodgings' at Bodiam more closely below.

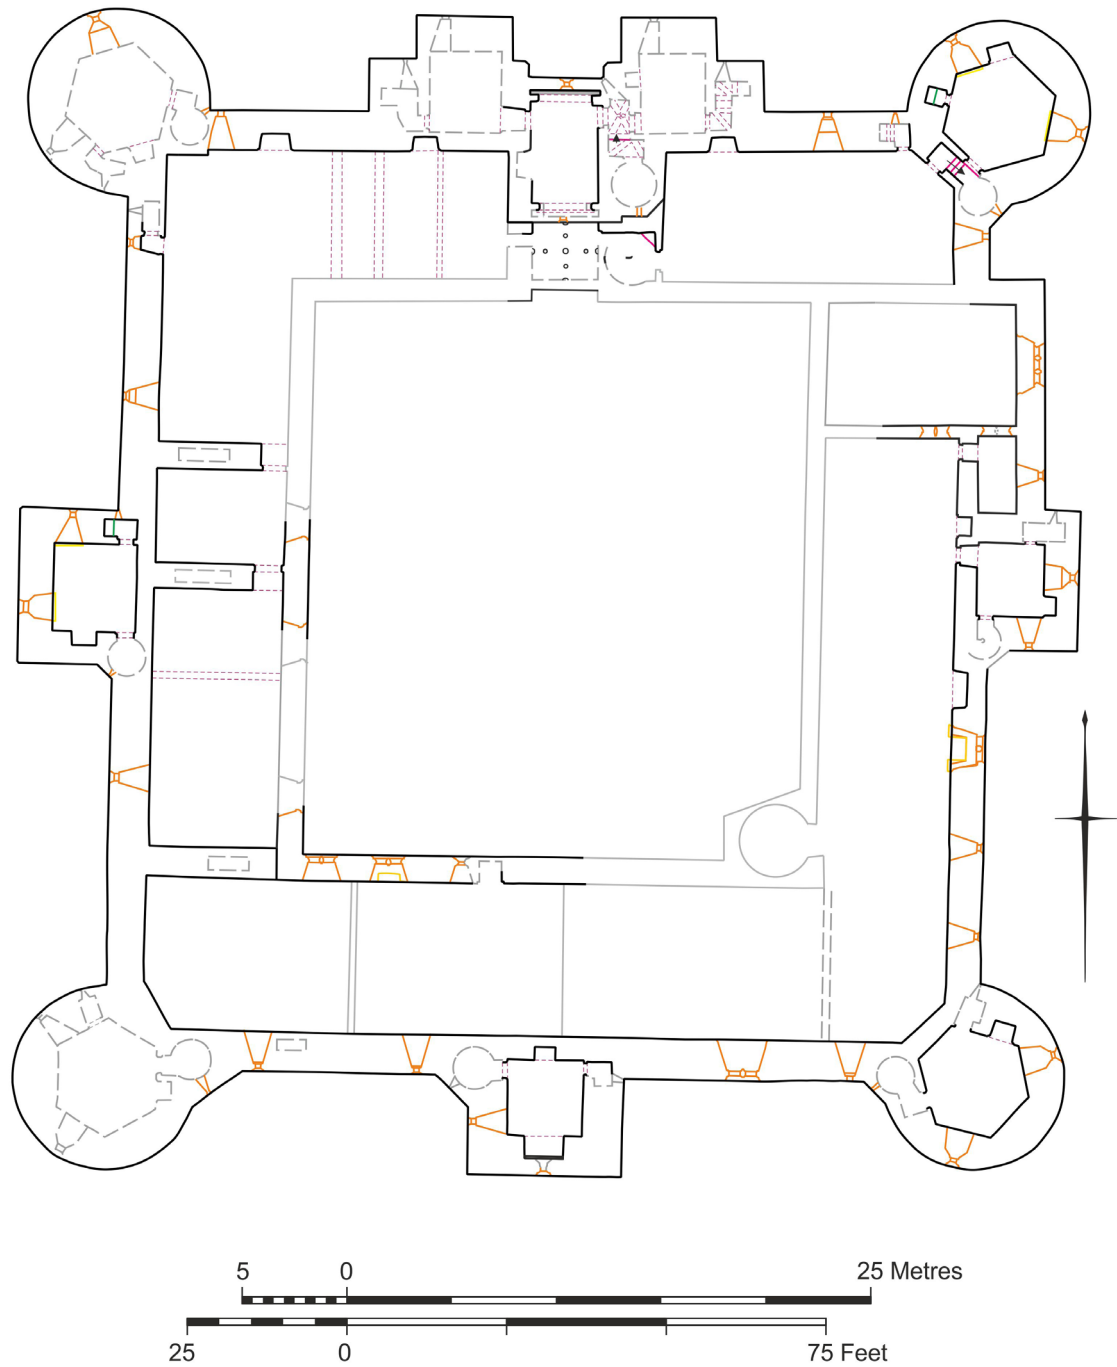
Fig. 3.6: Bodiam Castle, upper floor plan.

Though perhaps more than 95% of the castle was examined in detail, it was not possible to gain access to all areas due to health and safety considerations (for example in the eastern part of the northern gatehouse). The restrictions on space in many of the small corridors and latrines made it impossible to carry the total station survey through to these areas and in these instances, measured survey was carried out on paper (Figs 3.4-3.8).

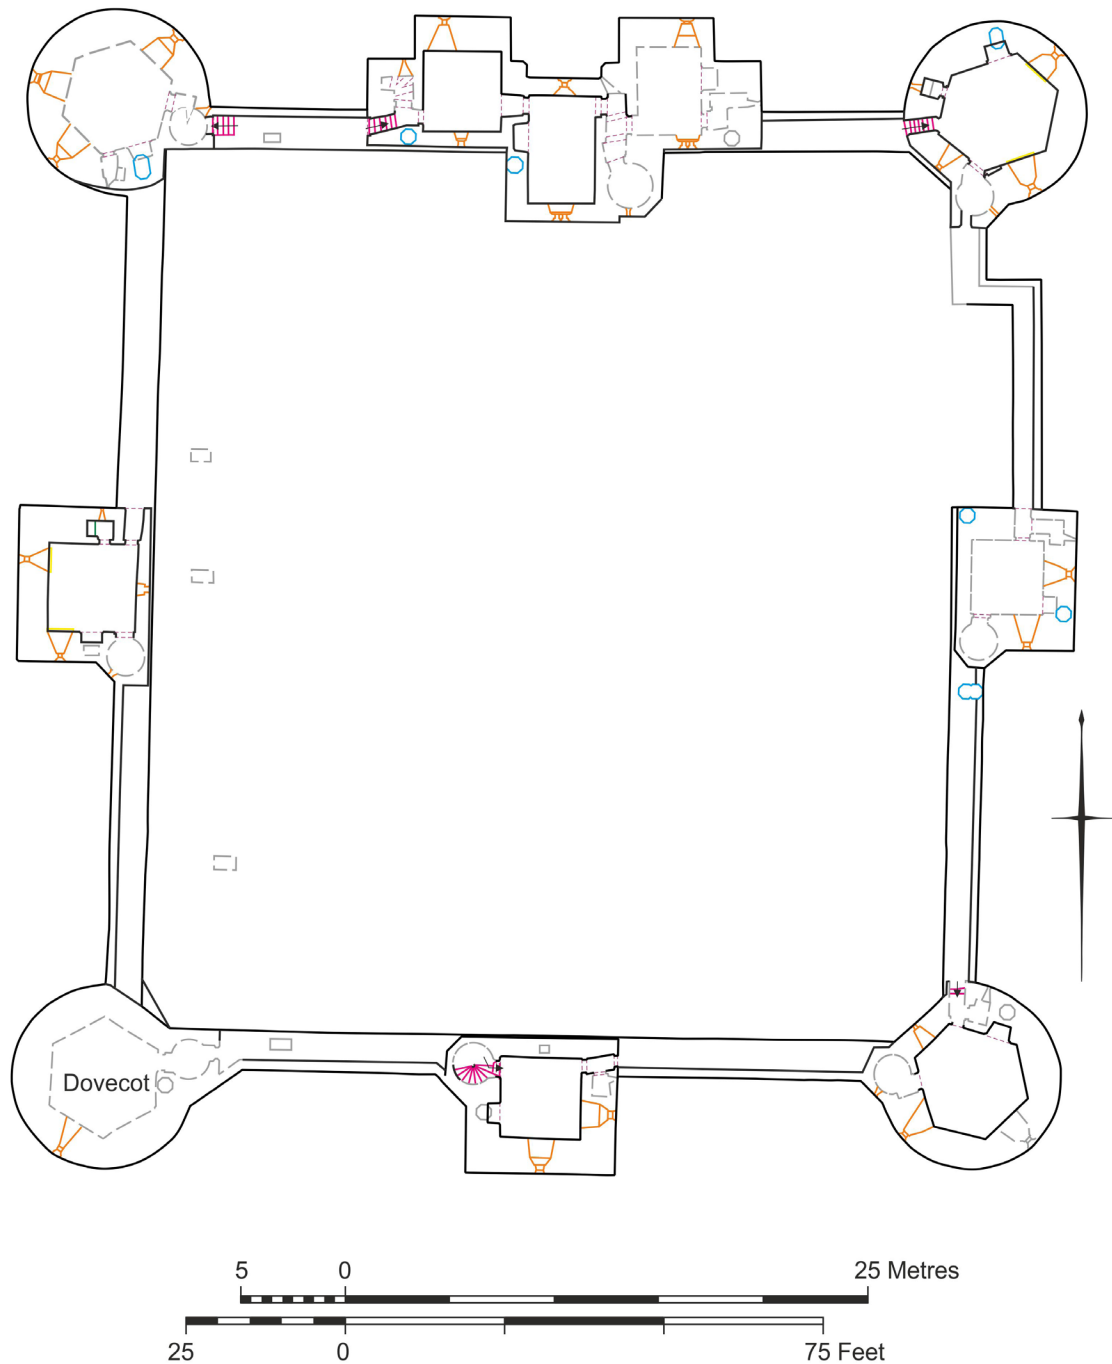
Fig. 3.7: Bodiam Castle, upper chambers plan.

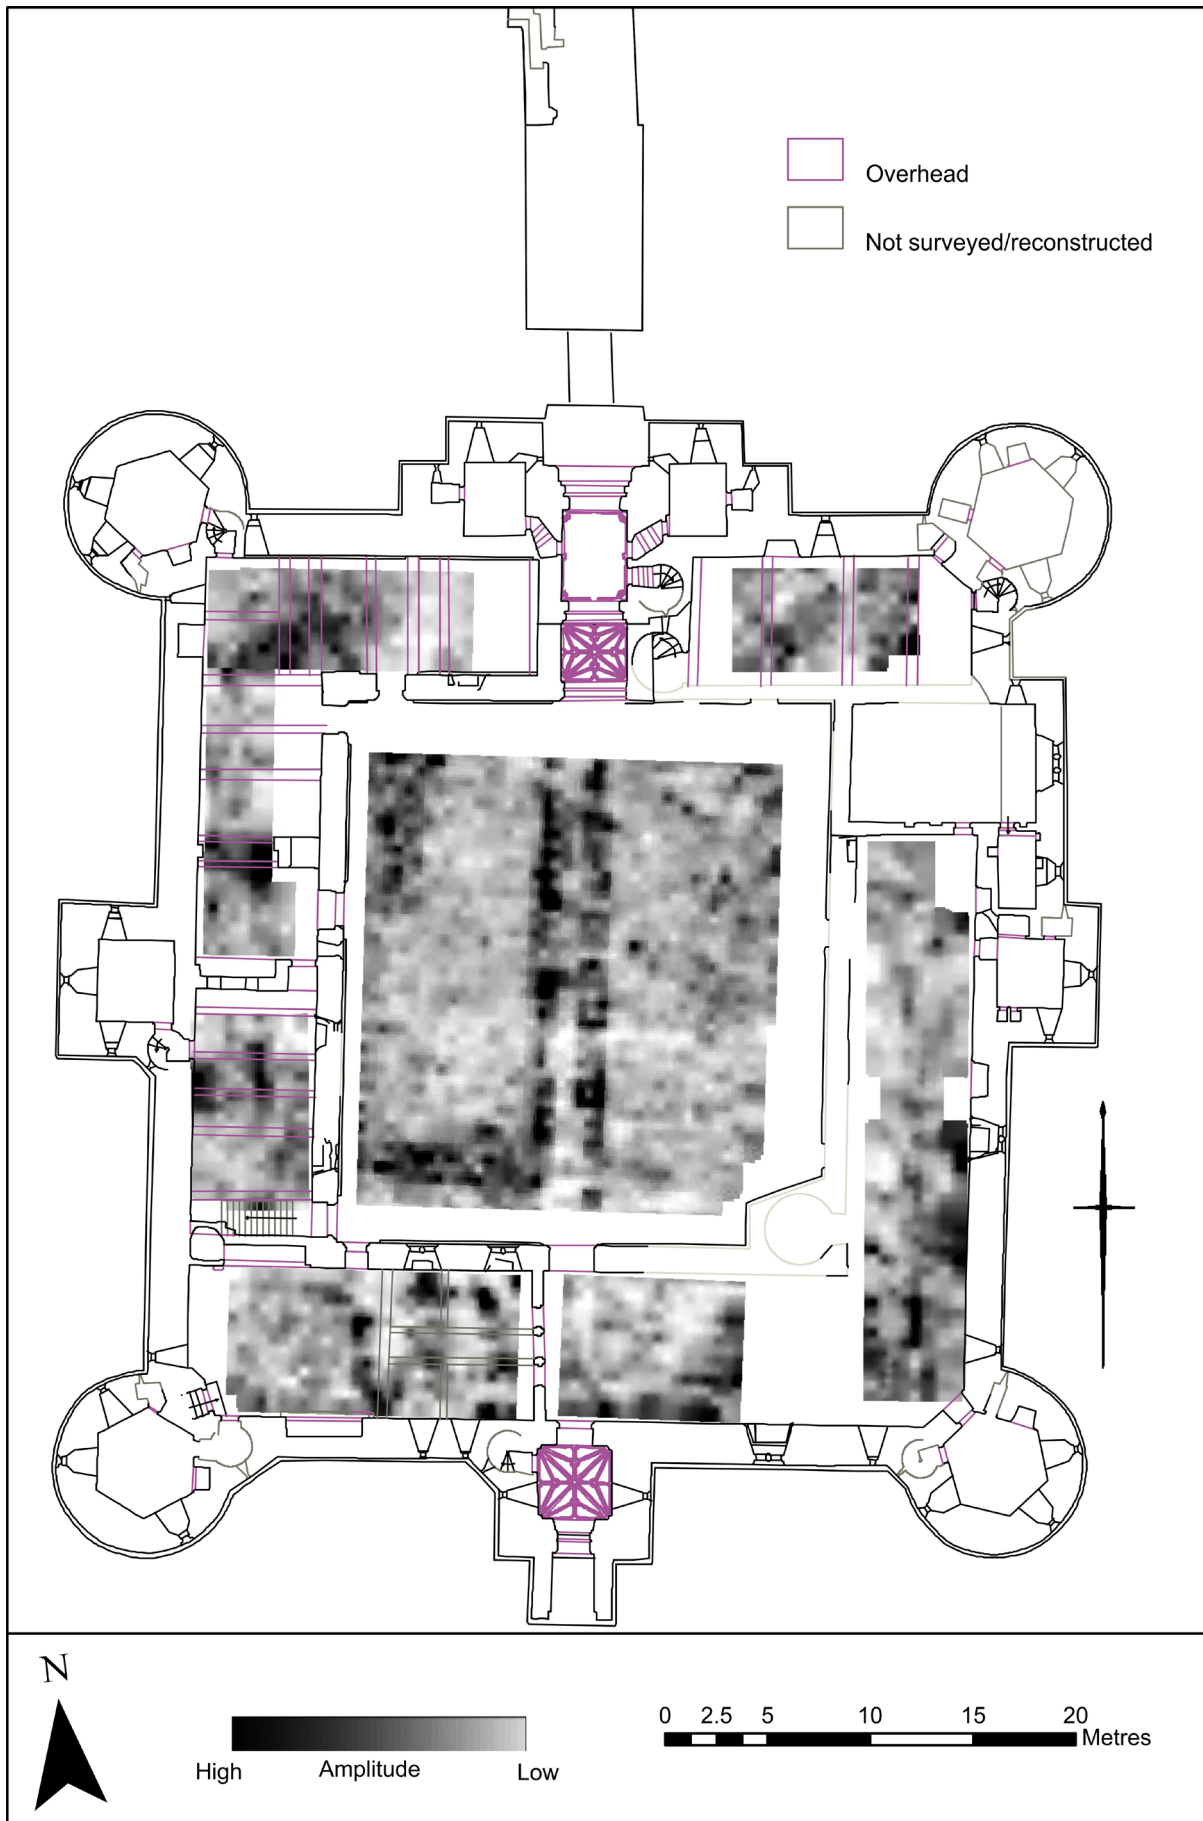
Fig. 3.9: Bodiam Castle, GPR results.

A GPR survey was also carried out of all areas of the castle interior where survey was feasible. Initial survey was carried out in 2010, directed by Kris Strutt. The team returned in 2016 to resurvey the area, and the results of this latter survey are presented in Figs 3.9 and 3.10, and are discussed below. A more detailed account and interpretation of the survey results is on file with Historic England.

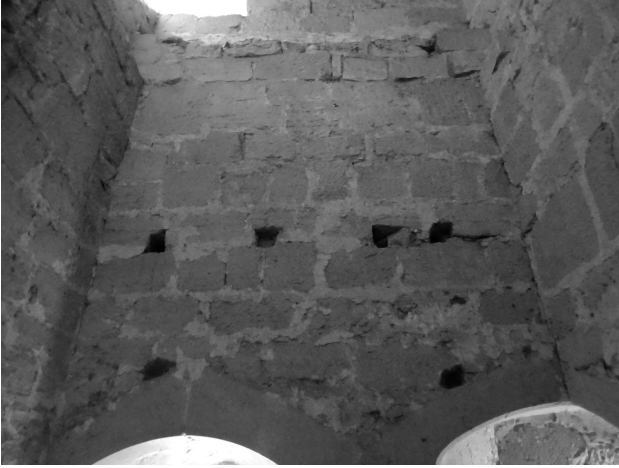
Fig. 3.11: Evidence for inserted floors, western ground floor room of gatehouse. Photo by Penny Copeland.

also Chapter Five). There is also evidence in many of the tower rooms of inserted floors to provide more space (Fig. 3.11). It could be related to agricultural storage but when and why this was done is not clear.

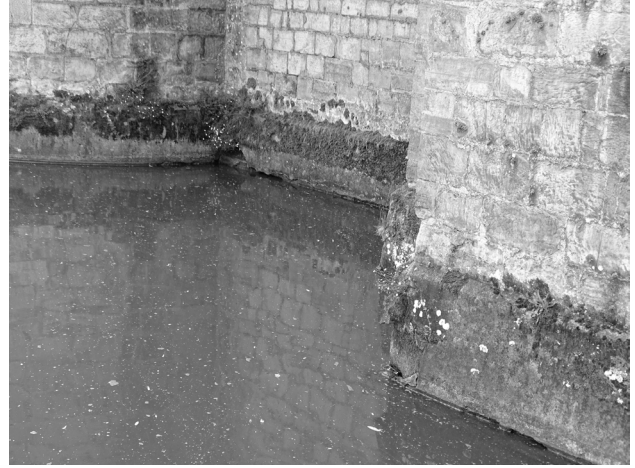
Fig. 3.13: Curzon's render to the plinth or 'apron'. Photo by Penny Copeland.

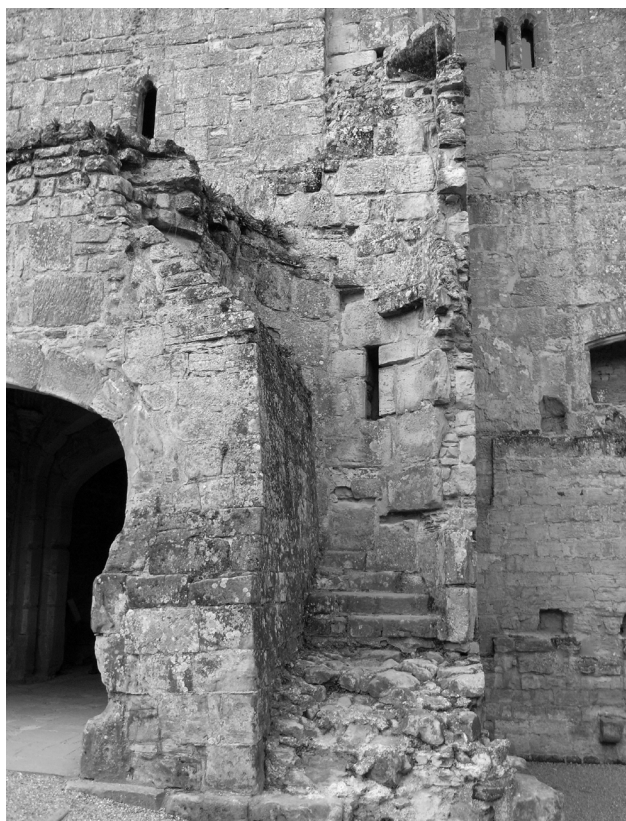
Fig. 3.14: Buttress against gatehouse, built up against stair to reach chamber. Photo by Penny Copeland.

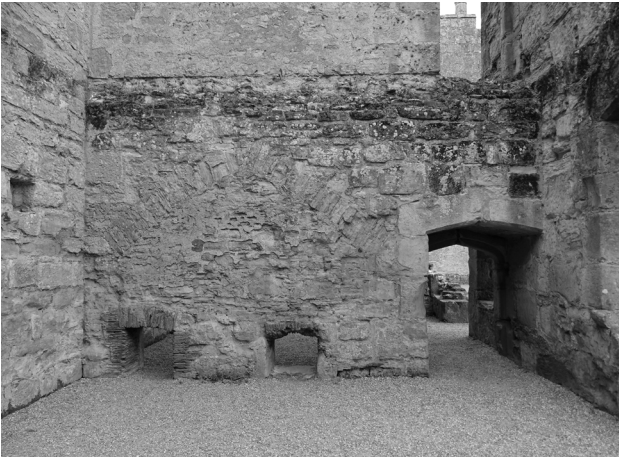
*Fig. 3.15: Southern cross wall of western range showing relieving arch and flue or stoke holes. A further retaining arch is visible on the northern side. Note knife sharpening effect on doorway. Photo by Penny Copeland.*

taken place on the door jamb in that room; such marks are more commonly found on or next to fireplaces (see Fig. 3.15). The GPR results (Fig. 3.10, D1) appear to show that the northern fireplace had a backing wall to the south suggesting the hearth opened to the north, presumably the earliest arrangement. There is also a door immediately to the east of this fireplace that has been blocked. The date of this blocking is uncertain but there is no indication of a door on Cubitt's plan so it must have been early. However, Paul Drury believes that although the fabric in this area dates from a late period of primary construction, it is not a much later phase, noting that the hearths are integral with the cross walls.

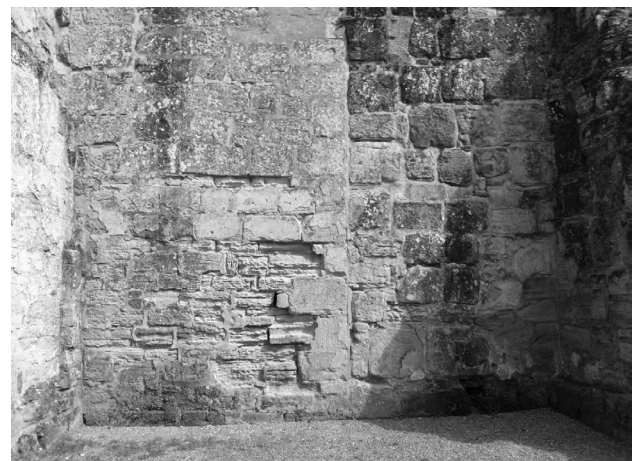
*Fig. 3.16: West side of gatehouse showing the straight joint between the original and the southern sections. Photo by Matthew Johnson.*

It is well known that the rear of the gatehouse incorporates changes of mind, apparently towards the close of the building campaign. The rear, southern, chamber of the gatehouse has a straight joint visible on the east and west sides to indicate that it has been added to the main structure at the front (Fig. 3.16). As a result, the chamber over the rear section is not connected to other chambers in the gatehouse, but is accessed independently from a separate staircase (Fig. 3.14). It is possible that this separate southern staircase gave access to the upper floor of the north-east range, and also, via the room above the southern gatehouse chamber, to the north-west range as well.

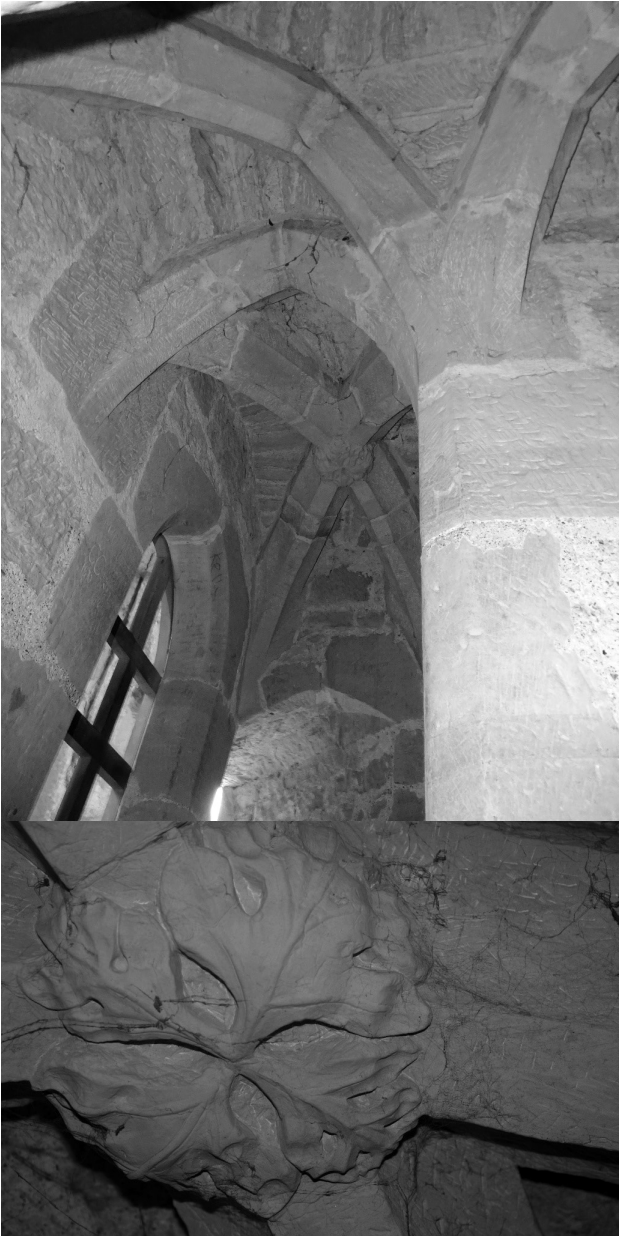
*Fig. 3.17: Leafy boss in the first floor corridor of the gatehouse. Photos by Penny Copeland.*

Less well known is the leafy boss (Fig. 3.17). This is the centrepiece of the vault in the narrow corridor linking the gatehouse stair to the first floor chamber over the gate passage and also to the chamber in its east tower; it was first pointed out to us by David and Barbara Martin. This boss is the only surviving piece of figurative sculpture in the whole building; Coulson has noted that the building as a whole is remarkably plain (1993: 76-7). There is an oral tradition that the boss has been moved to this location from the now-ruined barbican, where such a boss is visible in a watercolour of 1784 by S.H. Grimm. However the extant boss is carved as a single piece with four radiating ribs and looks particularly well built in to the surrounding stonework. The Grimm drawing shows the barbican boss with six radiating ribs which, if it is accurate, must rule out its identification with the extant boss. It is possible that there were further carved bosses in

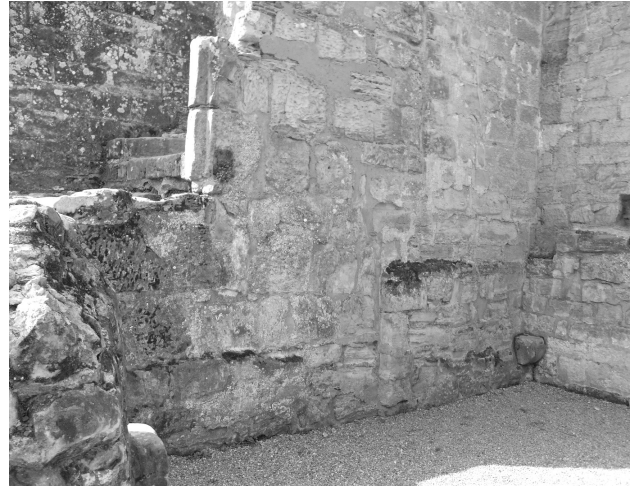
*Fig. 3.18: Plinth to the east of the gatehouse showing a slight misalignment reused to support a beam. Photo by Penny Copeland.*

A further anomaly exists at basement level to the east of the gatehouse. What appears to be a small plinth

protrudes from the northern half of the gatehouse, on a slightly different alignment from the wall above. A further small plinth protrudes at a lower level on the southern half of the gatehouse (Fig. 3.18). Both these plinths would be concealed on the western side if they exist, as there are no basements on this side. Neither of these plinths has corresponding features on other walls.

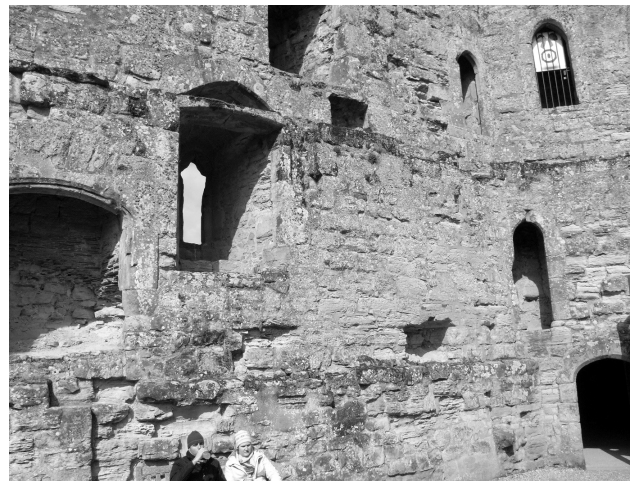
*Fig. 3.19: Window in north-east range of unusual design. Photo by Penny Copeland.*

The curtain wall east of the gatehouse has fireplaces and windows consistent with lodgings over two storeys. However, there is one window that is anomalous (Fig. 3.19). Its apex is too high for the ceiling of the lower floor, and is also of a unique design within the building. A further window in the south side of the north-eastern range has the top of the window apparently above or very close to the floor level above. Unrelated to the window, there has been a possible subsequent insertion of a cross wall dividing up this range, indicated by a low amplitude trench in the GPR (Fig. 3.10, F1) running from north to south, lining up with a corbel and roof timber notch.

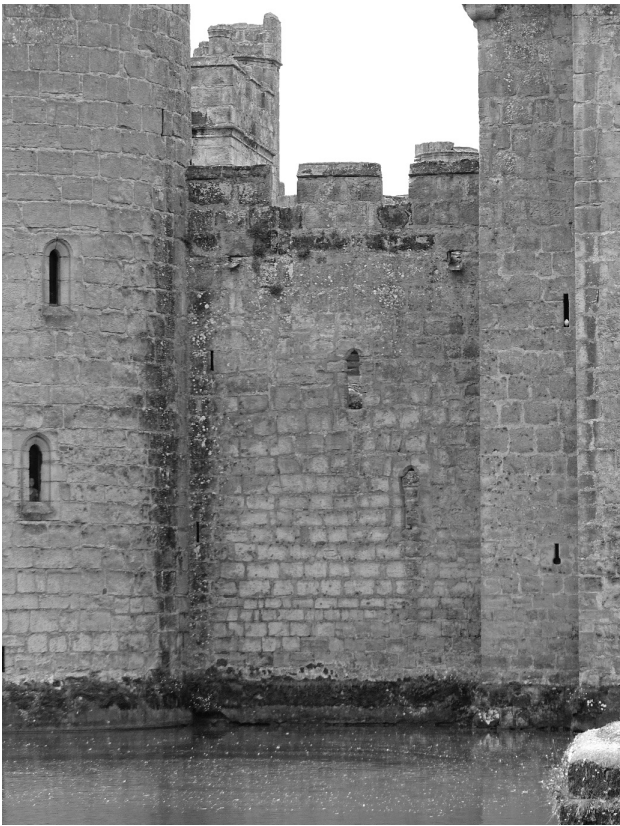
Fig. 3.20: Straight joint in external wall to east of gatehouse. Photo by Penny Copeland.

On the exterior wall between the gatehouse and the north-eastern tower there is a straight joint in the masonry (Fig. 3.20). This is probably no more than the result of masons working in different teams or in different building seasons but there may have been some ancient structural failure here as a crack seems to have been filled between seasons. There are stones above the crack which appear to be original but do not display signs of cracking.

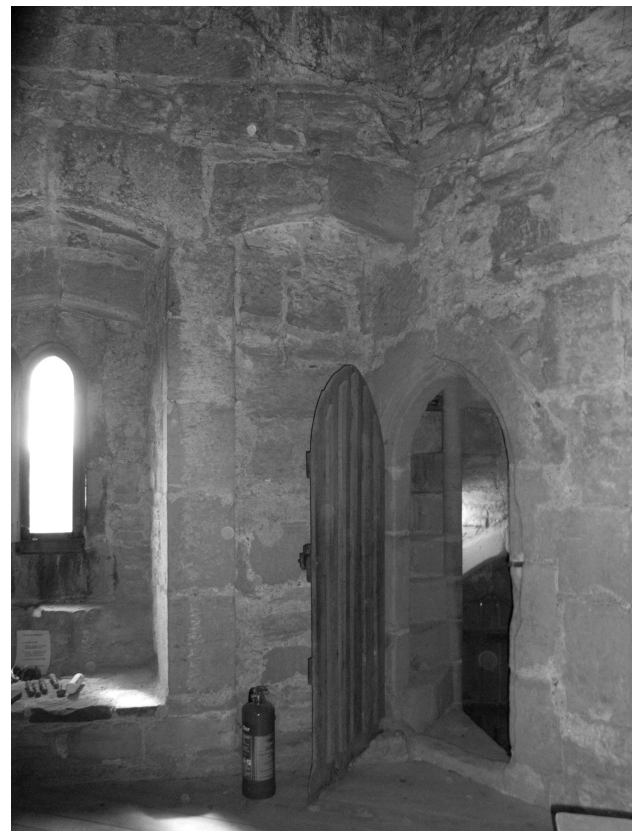
Fig. 3.21: Recess with lintel in wall of chamber floor of north-east tower. Photo by Penny Copeland.

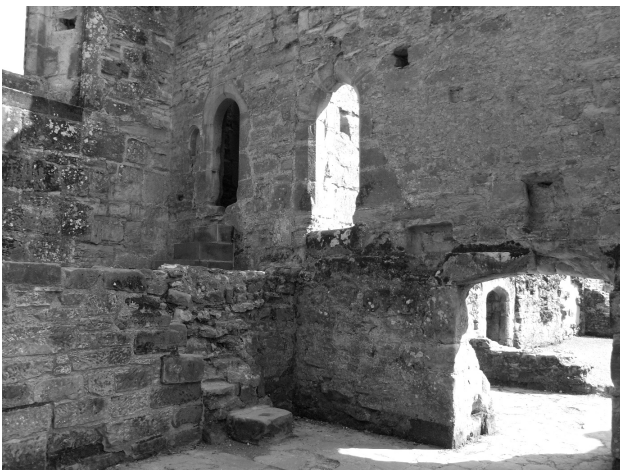
Fig. 3.22: Differences in floor levels in the chapel. Photo by Penny Copeland.

The two doors on the south side of the chapel, giving access to the private apartments and the sacristy respectively, are on different levels (Fig. 3.22); the stairs up to the sacristy have been restored, probably by Curzon. A difference in level between the altar space and the rest of the chapel is to be expected, but the sacristy is on a third, higher level again. This means that the door leading into the sacristy is higher than the door leading into the apartments. It is an unusual arrangement, with the areas below the sacristy and the chancel altar of the chapel being the only 'dead' spaces in the castle, with no access and no apparent purpose.

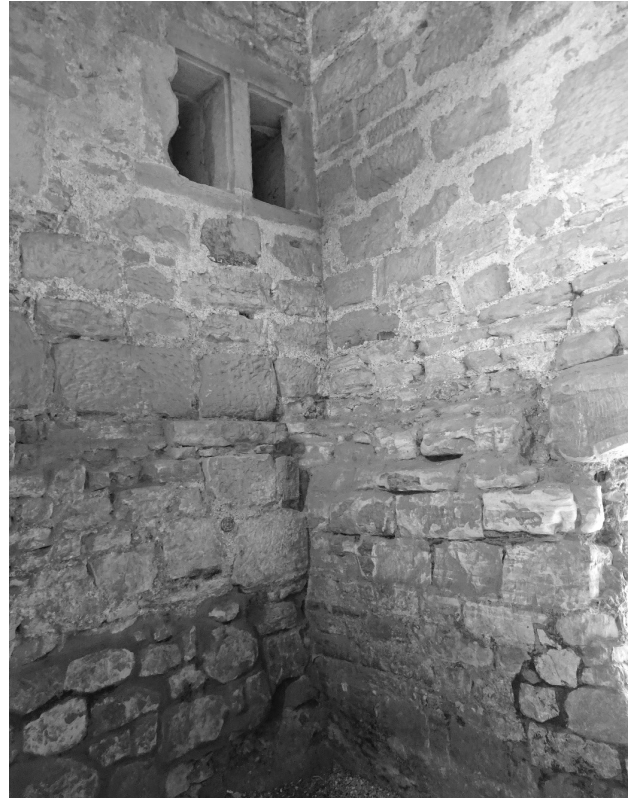
Fig. 3.23: Straight joint and rebuilt walls in basement level of east tower, also showing cupboards where stair access would normally be. Photo by Penny Copeland.

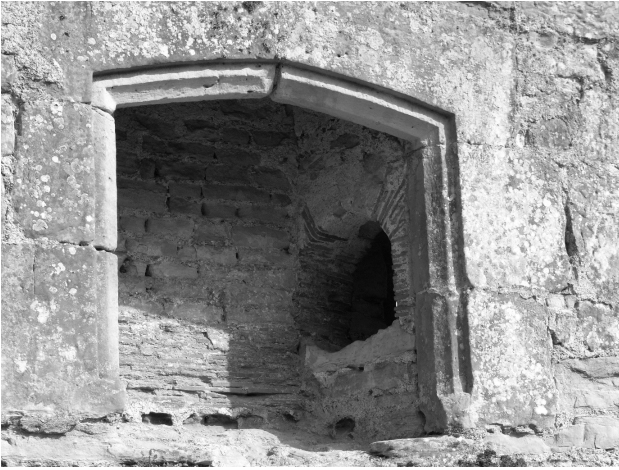
*Fig. 3.24: Fireplace in main range that connects through to east tower recess. Photo by Penny Copeland.*

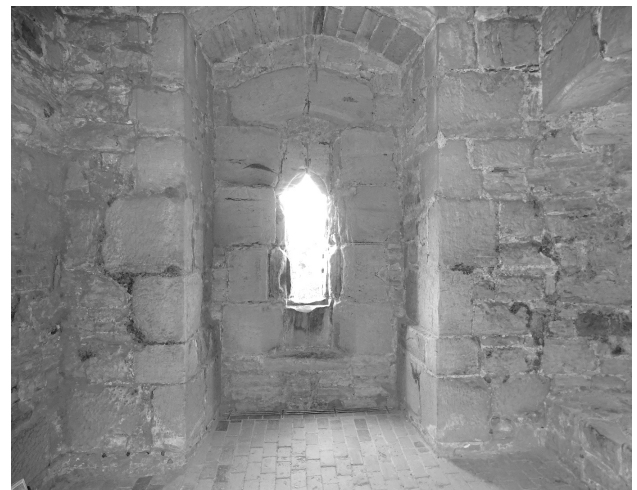
*Fig. 3.25: Possible sites of mortices for drawbridge chain. Photo by Penny Copeland.*

In the upper floor chamber over the gatehouse, a pair of mortices in the southern wall, about 1.5 m above the present floor, might be made out. Copeland and Cooper interpret these as possible mortices for a drawbridge chain. Johnson is not persuaded that these mortices exist; it is certainly the case that if these really are mortices that were subsequently plugged, the plugging was done very neatly. Readers can make up their own minds (Fig. 3.25). There are also two mortices lower down in this wall, just above the present floor. These have been plugged with lead and stone, possibly at the same time the vaulting below was protected with a roof, an action we attributed above to Fuller.

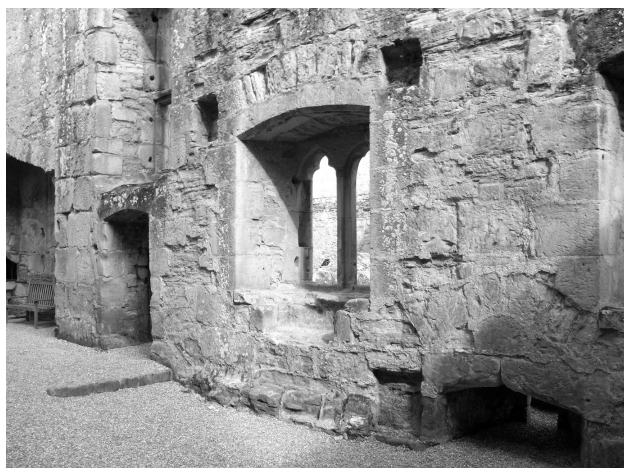
*Fig. 3.26: Window to basement of service range excavated by Curzon, also showing the substantial mortices for wall partitions. Photo by Penny Copeland.*

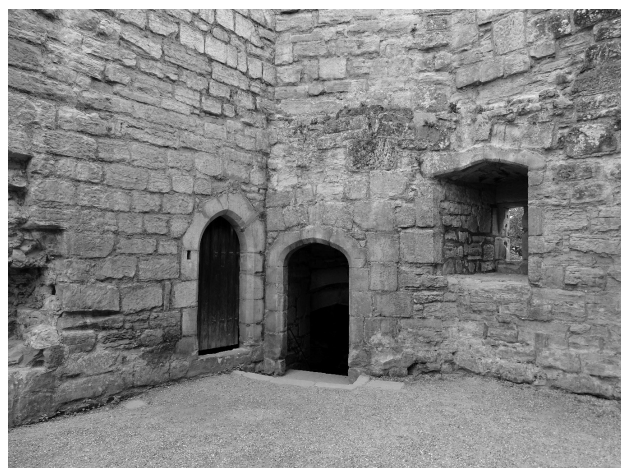
*Fig. 3.27: Kitchen layout showing the unusual ledge at upper floor level for a possible partition of the well and staircase areas. Note the difference in height and width between the staircase door and the well door. Photo by Penny Copeland.*

The entrance to the chamber containing the well in the south-west tower protrudes slightly from the line of the wall above (Fig. 3.27). The first angle is almost

90 degrees from the south wall; it is then angled north-west to meet the west external wall. The wall above for the first floor has a single angle between the south and west walls, but the angle neither runs parallel to the tower or to either of the walls below. The change in angle of the first floor creates a ledge; however it is not clear what the ledge is for. The possibility that this supported a floor runs counter to the indication of the full height window and the assumption that the kitchen was two storeys high. There may have been a partition at this point with joists for a mezzanine resting on the ledge. A further detail of this area is the raised step into the staircase doorway next to the well. We can imagine the kitchen being mopped regularly and this raised step would have kept the water and grease out of the area. This might also explain the raised floor level in the pantry/buttery area.

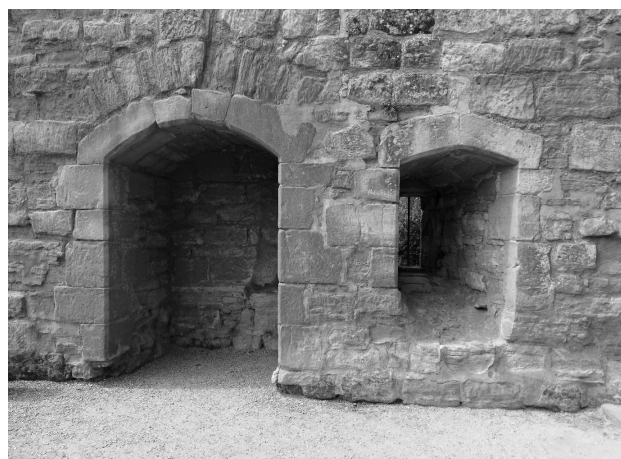
*Fig. 3.28: Double latrine and window at northern end of western range with inconsistent chamfers. Photo by Penny Copeland.*

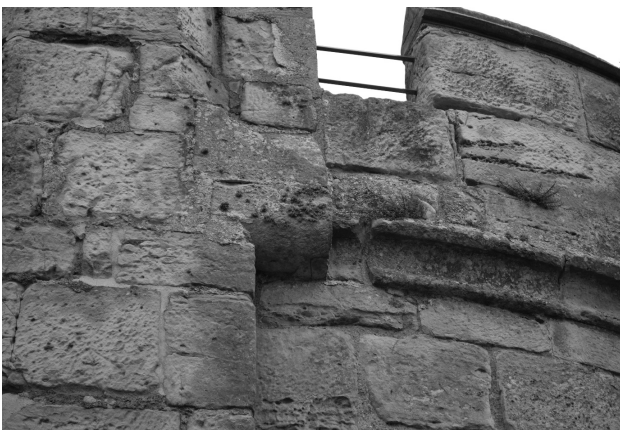
*Fig. 3.29: Change from corbel to string course on the north-west tower. Photo by Penny Copeland.*

The north-west tower has an odd plan externally. Where the other towers have diagonal walls on the courtyard face, here there is an internal right angle, as if a 'bite' has been taken out of the plan. Just below parapet level on the east side of the tower above the wall-walk door, there is what appears to be a single corbel with no apparent function. The string course common to all towers without gates ends here just short of the corbel (Fig. 3.29). It is possible that the stones here were some of those replaced by Curzon, but there is no other indication of restoration at this point. A notch has been carved above this corbel, possibly to divert rainwater from its top, similar to treatment of chimneys against walls in other areas.

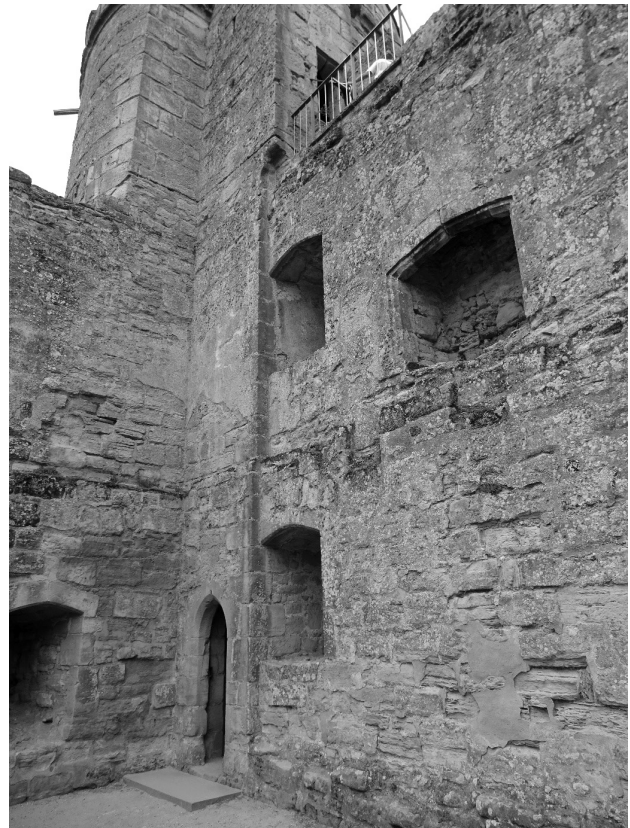
*Fig. 3.30: Possible straight joint between north-west tower and north wall. Photo by Penny Copeland.*

There is a straight joint between the north-west tower and the adjacent curtain wall, when observed internally, with the tower apparently built up against the wall. This may be another result of different masons' activities, particularly when it is considered in conjunction with the small but unique rebate with slight overhang/notch found where the northern elevation meets the north-western tower (Fig. 3.30).

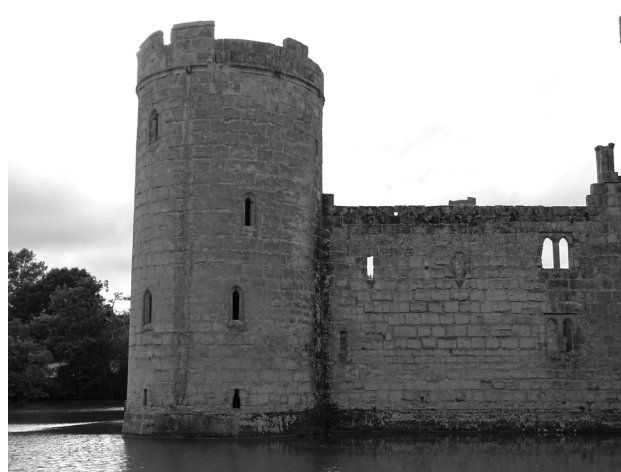
*Fig. 3.31: Southern section of the east curtain wall showing different building seasons. Photo by Penny Copeland.*

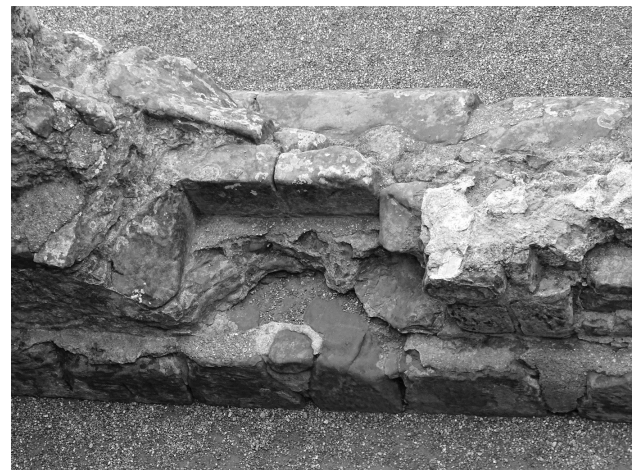
*Fig. 3.32: Window seat and plinth in northern range often interpreted as stables. Photo by Penny Copeland.*

The north range west of the gatehouse has been identified as stables, and the position is at first sight a logical one. However the doorways appear to be too narrow for this purpose, and the plinths for a suspended floor argue against this, although GPR anomalies indicate possible subsurface drains both here and on the other side of the gatehouse (Fig. 3.10, E1-E3 & F2). Indications in the GPR results of foundations of a cross wall between 'stables' and western service range should also be noted here (D4 & D5). There is also evidence for a large window with a window seat (Fig. 3.32) – an unusual feature for a stable. If the stables are indeed not within the central court, they must be elsewhere, and we suggest below that they may have been sited on the ridge to the north as part of a detached 'base court'.

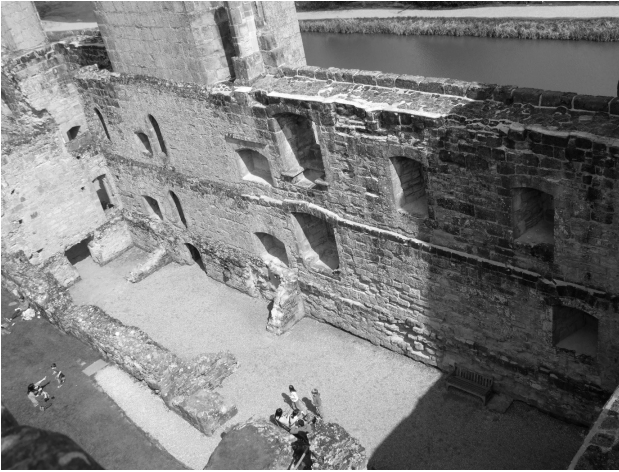
*Fig. 3.33: Suites at the upper end of the hall, viewed from the summit of the southern gatehouse; see also Fig. 3.7. Photo by Matthew Johnson.*

At the upper end of the hall, running up the east range, are two suites, each indicated by fenestration and other features and divided up by now-vanished timber partitions (Figs 3.7 & 3.33). Both consisted of an unheated outer room, an inner chamber with fireplace and window seat, and a further inner chamber with fireplace and window seat facing onto the courtyard. Both inner chambers have doors to rooms in the east tower, which do not intercommunicate. This is the only tower where these two levels do not have a connecting stair. The lower suite has a door into the chapel, while

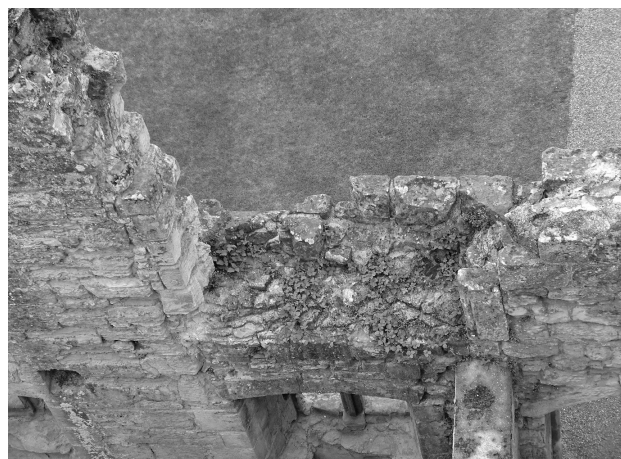
*Fig. 3.34: View down only narrow window jamb to west, and rebated door jamb to right. The door jamb sits slightly over the triple door wall at the end of the Great Hall. Photo by Penny Copeland.*

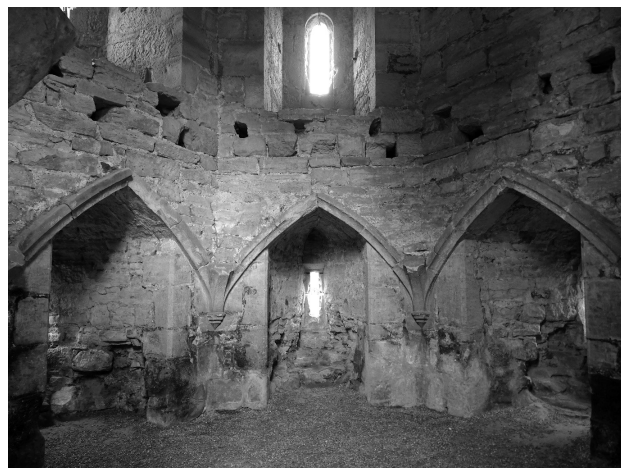
*Fig. 3.35: Vaulted basement room of the south-east tower. Photo by Penny Copeland.*

and to the floor above. The south-east tower has a vaulted basement (Fig. 3.35). The vault is now largely destroyed but enough remains to indicate that it was finely constructed in a manner similar to the gatehouse vaults. The function of this room is not certain but its location at the lower end of the private apartments and just off from the Great Hall suggests it may have been a strongroom similar to rooms found at Penshurst, Ightham and Great Chalfield. The south-west tower has a well in the basement and a dovecote in its upper storey; this tower was heavily restored by Cubitt and later Curzon (Fig. 3.36). Large parts of the dovecote have been entirely rebuilt but enough remains to demonstrate that it was an original feature of the 1380s.

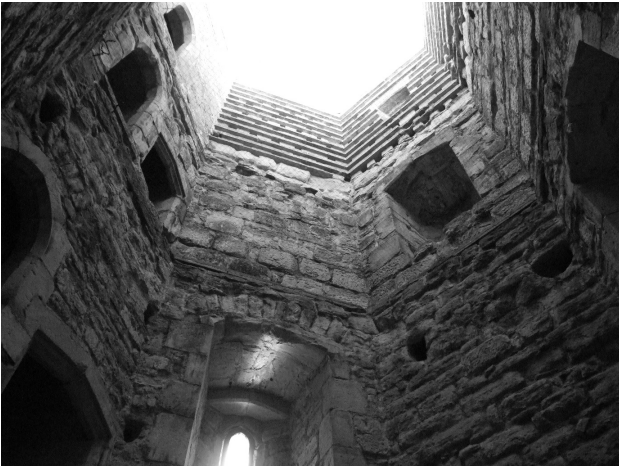
Fig. 3.36: Interior of south-west tower, with two lodgings and a dovecote above, partially restored. Photo by Penny Copeland.

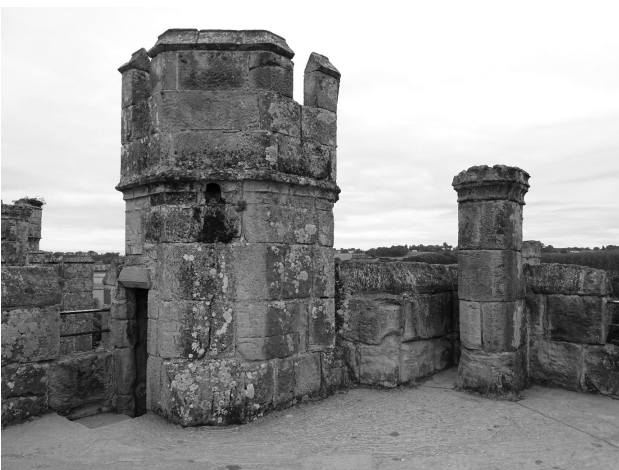
Fig. 3.37: Stair turret and chimney of the north-west tower. Photo by Penny Copeland.

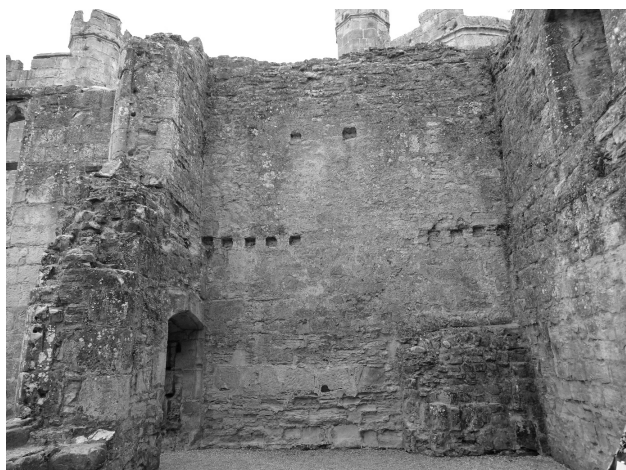
*Fig. 3.38: Floor joists with gap for trimmer and faint scar in surviving plaster for staircase from ground floor against the external northern wall of the kitchen. Note the rebuilt oven below. Photo by Penny Copeland.*
