Paper Title: STUDY OF OVERHEIGHT VEHICLE COLLISIONS WITH HIGHWAY BRIDGES

STUDY OF OVERHEIGHT VEHICLE COLLISIONS WITH HIGHWAY BRIDGES

ABSTRACT

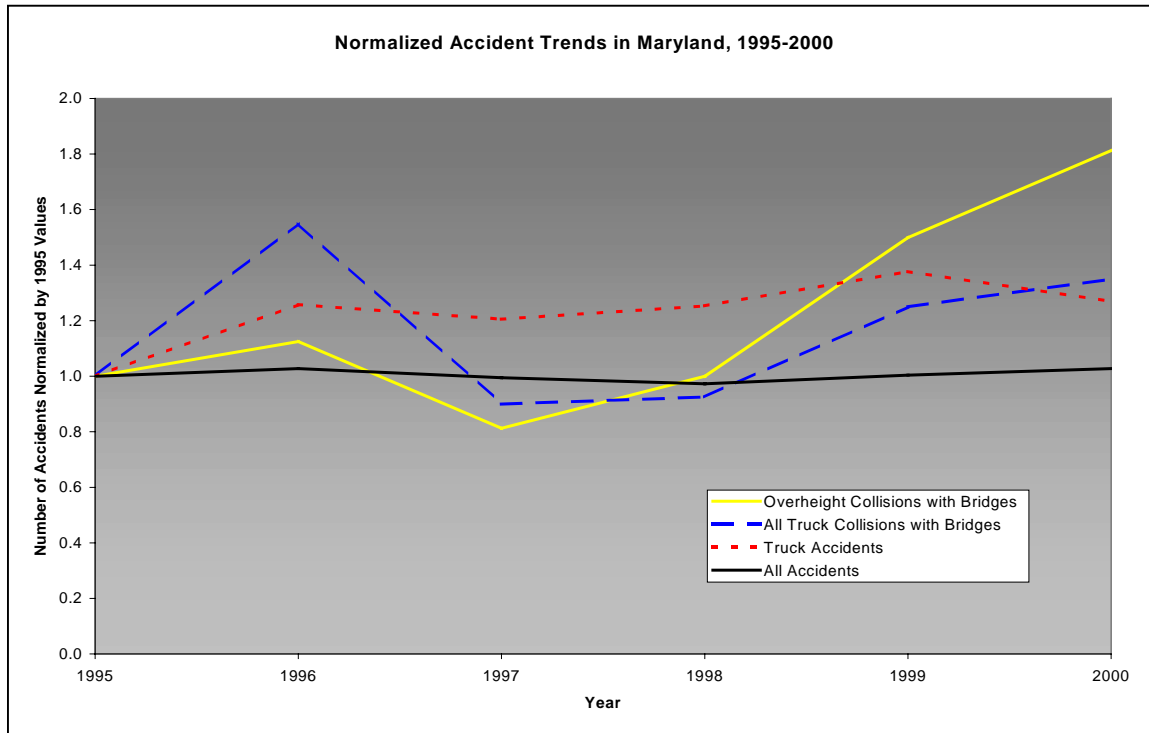
Figure 1. Normalized Accident Trends in Maryland, 1995-2000

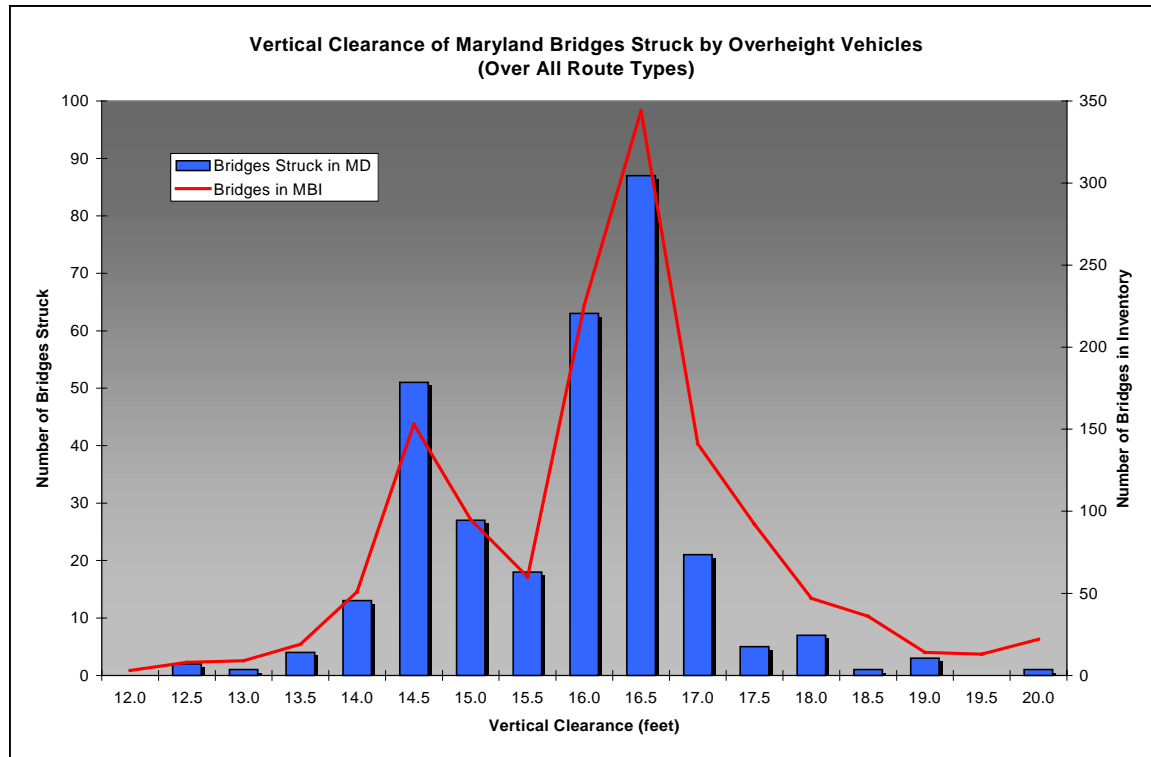
Figure 2. Vertical Clearance of Maryland Bridges Struck by Overheight Vehicles

The two distinct peaks in Figure 2 indicate the existence of two different populations of bridges: those designed for a standard vertical clearance around 4.4 m (14.5 feet), and those designed for a clearance around 5.0 m (16.5 feet). These two groups can be isolated by classifying the type of route underneath the bridge. Minimum

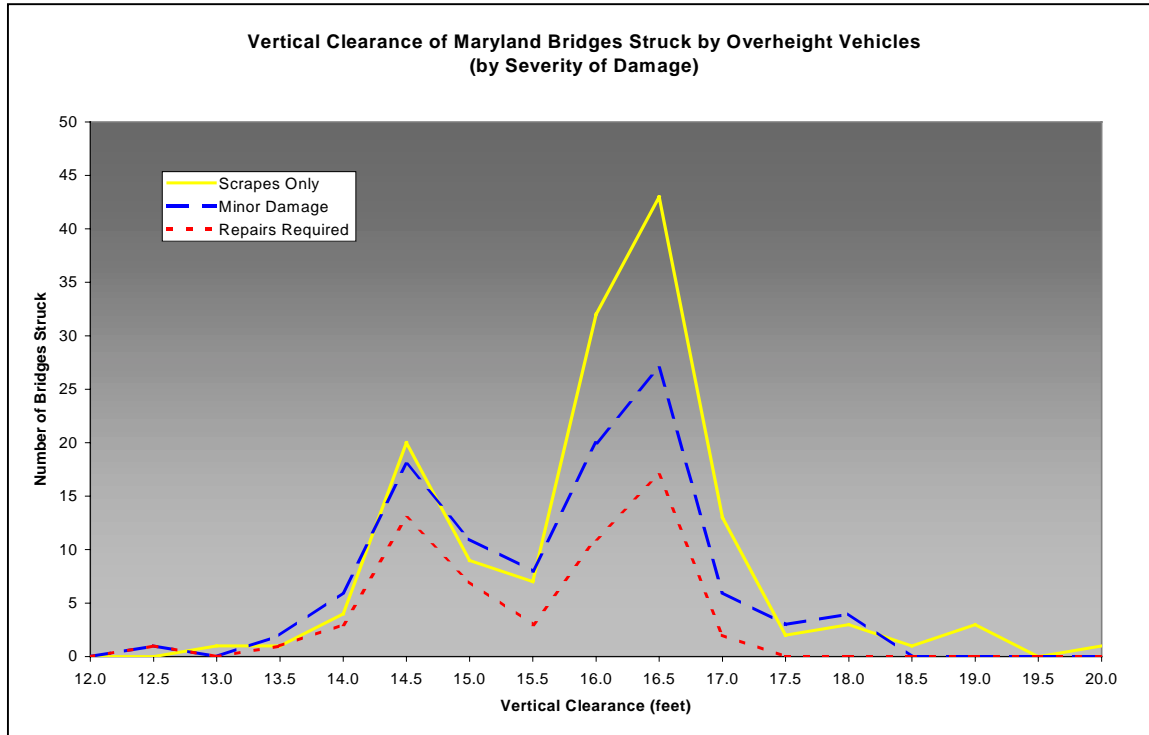
Figure 3. Vertical Clearance of Maryland Bridges Classified by Damage Severity

Damage severity was broken into three categories. The first consists of superficial scrapes and gouges. The second category refers to minor bends, tears, or cracks not needing immediate repairs. The third level is defined as any damage for which repairs were deemed necessary. Of the 309 bridges struck by overheight vehicles, 144 received scrapes only (47%), 107 sustained minor damage (34%), and 58 required repairs (19%). This distribution is similar to that observed by Feldman et al. for damaged prestressed concrete girders in Texas (61% minor, 25% moderate, 14% severe). To better gauge the magnitude of overheight damage statewide, these numbers can be compared to the total of impact-susceptible bridges. Of the 1496 bridges that could be struck by overheight vehicles statewide, 1187 (79%) have no observable impact damage, 144 (10%) have scrapes only, 107 (7%) have sustained minor damage, and 58 (4%) have required repairs. To observe any correlation between damage severity and vertical clearance, the distribution of clearances was plotted for each level of damage (Figure 3).

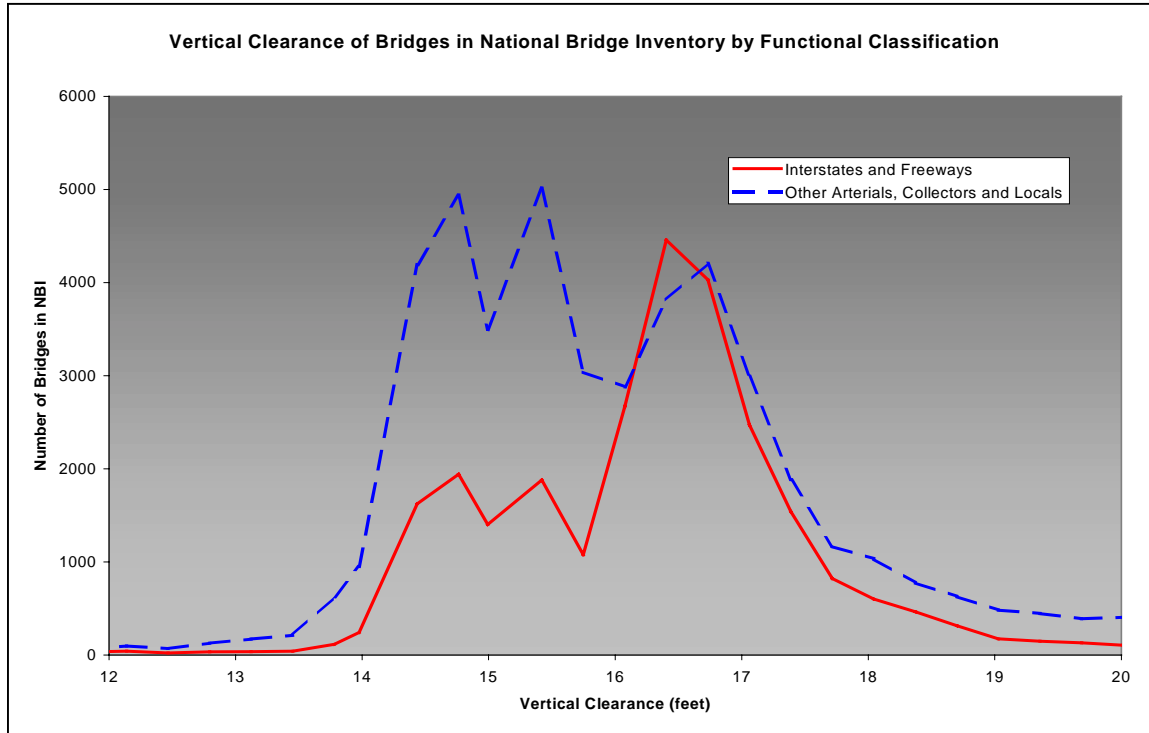
Figure 4. Vertical Clearance of Bridges in NBI by Functional Classification

The NBI includes the vertical clearance of all bridges in the country. As with the Maryland data, the NBI clearance distribution can be broken down by type of highway. The data provided by the FHWA includes a breakdown by functional classification. The bridges are separated into two groups: Interstates and Freeways; and Other Arterials, Collectors, and Locals. The results, plotted in Figure 4, are similar to those for Maryland (Figures 3

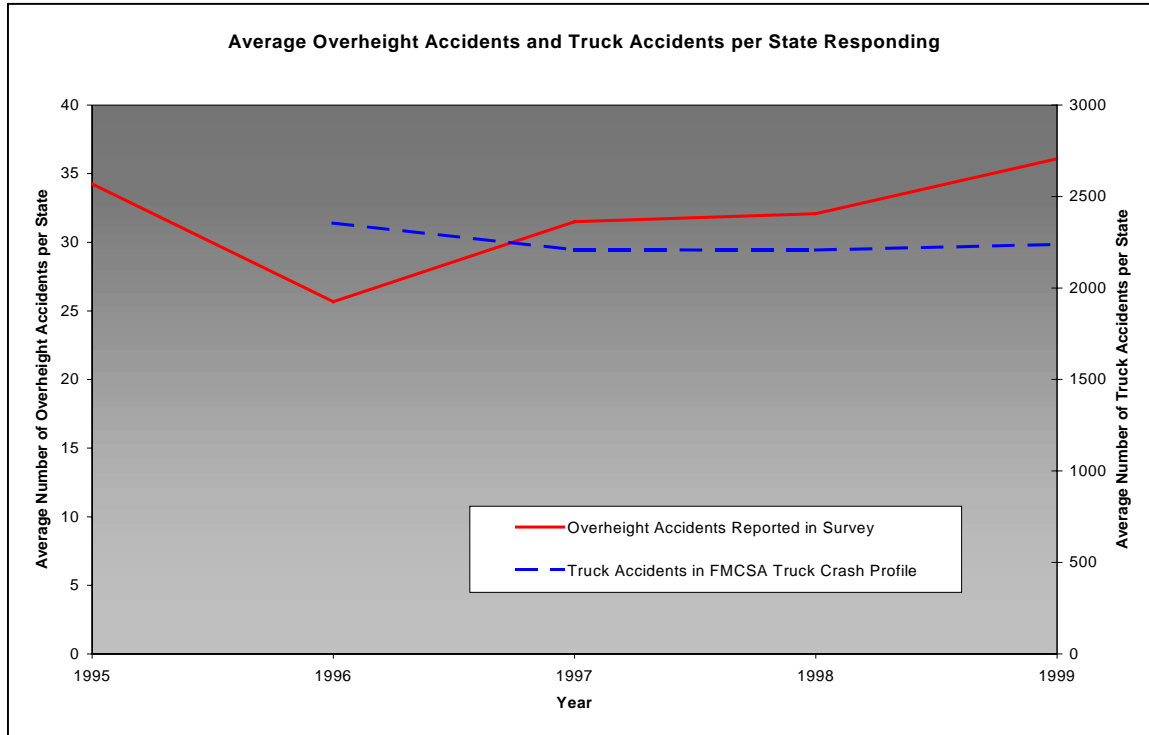
Figure 5. National Average Overheight Accidents and Truck Accidents per State Responding

Seventeen states indicated that they maintain records on overheight collisions. Of these states, four collect their data from accident reports only (24%), five from bridge inspections only (29%), and eight from both sources (47%). Only six other states reported using a computerized accident database like Maryland's MAARS program. Twelve states provided numbers of overheight collisions for the years requested. The records for each particular state vary over the study period, with some increases and some decreases over time. On average, there is a slight increase over the five-year period. The average number of overheight collisions is about five percent greater for 1999 than for 1995, an increase of 1.3% per year. To compare this to the general trend in truck accidents, statistics for these twelve states were taken from the Truck Crash Profile maintained by the Federal Motor Carrier Safety Administration (FMCSA). The Truck Crash Profile contains annual data on truck accidents from 1996 to 1999, drawn from the Fatality Analysis Reporting System (FARS) and the Motor Carrier Management Information System (MCMIS). For the same twelve states considered above, the average number of reported truck accidents decreased by five percent from 1996 to 1999, a drop of 1.7% per year. The two trends are plotted in Figure 5.
