## EVALUATION OF A PROTOTYPE SOLAR AWNING

A prototype solar awning has been designed and installed on a University of Oregon campus building. The solar awning is composed of a light shelf with photovoltaic modules attached tilted 20° to the south. An interior light shelf and LED lights have been installed along with monitoring equipment to evaluate the total amount of energy produced by the system and saved by reducing the heat load of the building. The system has been extensively monitored and the analysis of this system will be used to evaluate the economics of solar awnings on campus buildings across the university system.

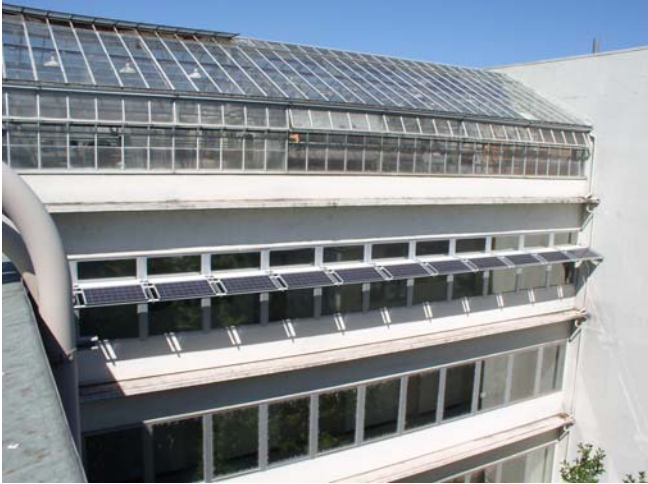
Fig. 1: Solar awning on the third floor of Pacific Hall. The modules are separated into two strings of six to minimize the shading problem on the whole system. The hallway on the second floor will be used as a control.

The prototype solar awning was located outside the third floor of a connecting bridge between two buildings. This connecting three-storey bridge building has a hallway with large windows on the south side and offices on the north side of the hallway (Fig. 1). The hallway often experiences excessive heat in the summer even with tinted film placed on the windows and air conditioning in adjacent wings of the building. The hallway on the floor below the awning has the exact physical attributes of the experimental third floor and will serve as a control when the awning cooling capacity system is tested this coming summer. The solar awning consists of 12 Sharp 80 Watt NE 80EJEA solar modules mounted in two strings of 6 modules each. Each string is

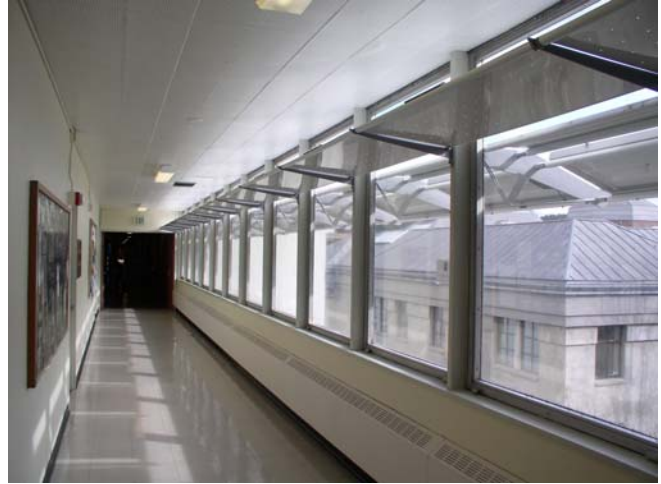
Fig. 2: Light shelf inside the hallway reflects light to the ceiling and spreads the daylight further into the building. LED lighting can be seen on the outer edge of the light shelf. Florescent lighting on the ceiling will be removed when the LED lighting becomes operational.

The inside edge of the interior light shelf is constructed so that the wires for the LED lighting can run along the edge of the light shelf (Fig. 2). The LED lighting will replace the florescent tubes that currently illuminate the hallway. Daylighting controls will be included in the circuit for the LED lighting to further minimize the use of electricity and to help designers and facility managers gain experience with daylighting controls and LED lighting.

A unique feature of this solar awning is the addition of a light shelf. The light shelf produces an interesting pattern of light in the hall (Fig. 2). Before the solar awning was installed the walls were painted pastel yellow with a 1.2 m (4 ft) high blue trim and the ceilings were off white for an average light reflectance of 40% and 70% respectively. To increase the indoor reflectance ratios for maximum daylighting and a reduction in glare index ratio of the windows to walls, a light yellow and pale green was used around the frames to increase the hallway’s reflectance to 75%. The ceiling tiles were painted white to increase the reflectance to 90%. The new paint certainly brightened the hallway and increased the daylight efficacy. When the solar awning was installed, the lighting level did increase because of the light self, but the glare was reduced because the awning blocked the direct sunlight at eye level.

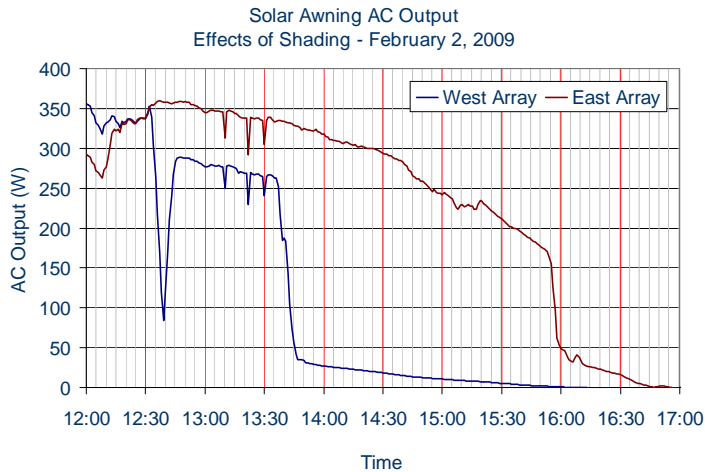
Fig. 4: AC Output of shaded versus unshaded array. The west array, lower trace, is shaded.

The solar awning is located outside a connecting corridor between two buildings that are subject to severe shading conditions. The two identical systems provide an ideal opportunity to evaluate the effects of shading on PV systems. Since only half of the array is shaded at a time, it is necessary to combine the output of the west side array in the morning with the output of the east side array in the afternoon to evaluate the performance of an unshaded array of equivalent size. While initially viewed as an inconvenience, this happenstance offered an excellent chance to evaluate the shading effects on PV array performance (Figures 4-7).

This is shown in Figures 8, 9 and 10 when the second panel is shaded at around 14:00 and the DC voltage is maintained at about 77 volts. When the third, fourth, and other panels are shaded there is little change as the PV system is already operating as if the whole array was shaded (Fig. 4).

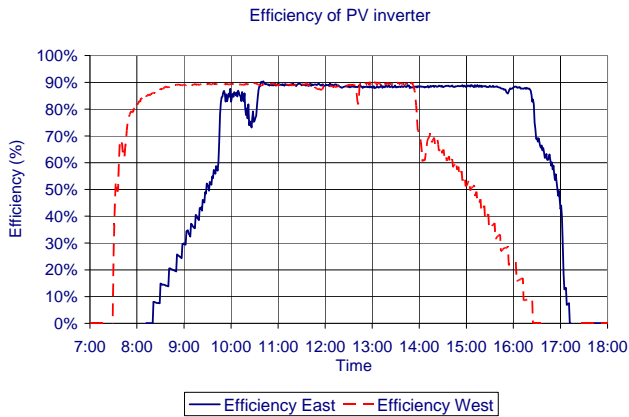
Fig. 8: Inverter efficiency drops when shadow first affects AC output. February 21, 2010. See drop at about 12:40.

point tracker in the inverter trying to adjust when the shading is reducing the output of the PV module and the bypass diode in the module is starting to divert the current around the poorly performing module. The efficiency of the inverter drops briefly from 90% to 80% (Fig. 8).

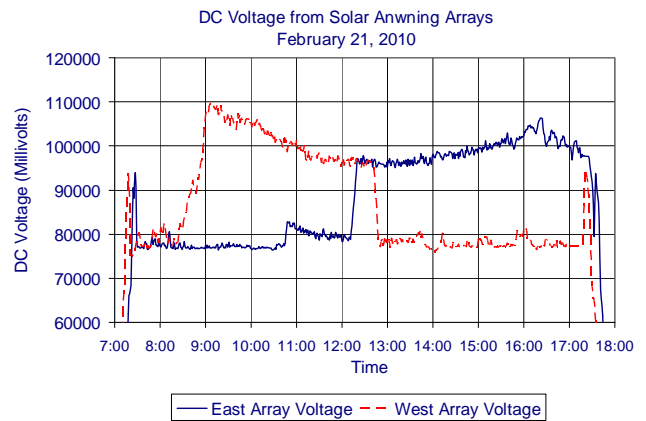
Fig. 9: DC voltage for the east and west arrays.

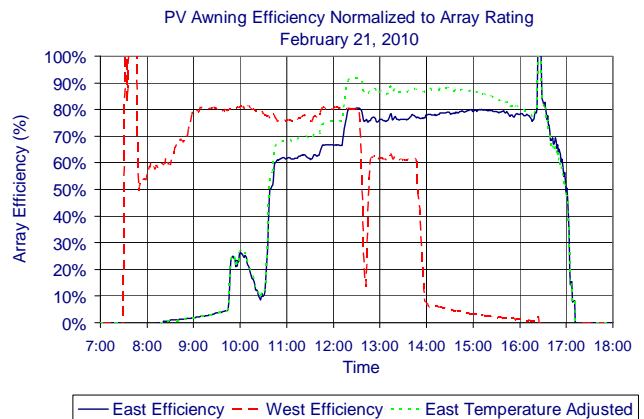
Fig. 13: February 2010—PV AC Output divided by system DC rating. The dotted line is the normalized ratio adjusted for a temperature of 25 Celsius.

A good method for comparing the system performance is to divide the AC output by the incident energy and normalizing the output by dividing by the DC rating of the array. This normalized performance ratio is show in Figs. 12-13.

When similar information is plotted for February 2010, the average array efficiency decreases by about 2%. Two days is a very limited sample. In addition, the uncertainty in the irradiance measurements has absolute uncertainties of about 5% and relative uncertainties of a percent or two. It is likely that the responsivity of the pyranometer decreases over time and the irradiance on the second period a year later should be increased by the proportion the responsivity of the pyranometer decreased. Therefore, the decrease in system performance degradation might be slight greater than the 2% observed without adjusting for pyranometer calibration change. Of course, comparisons on many more than two days are needed to ascertain the true decrease in performance with any level of confidence. It should be noted that there is a decrease in measured tilted irradiance around noon. The cause of this phenomenon is unknown, but it has been observed at the same time in data taken one year apart.

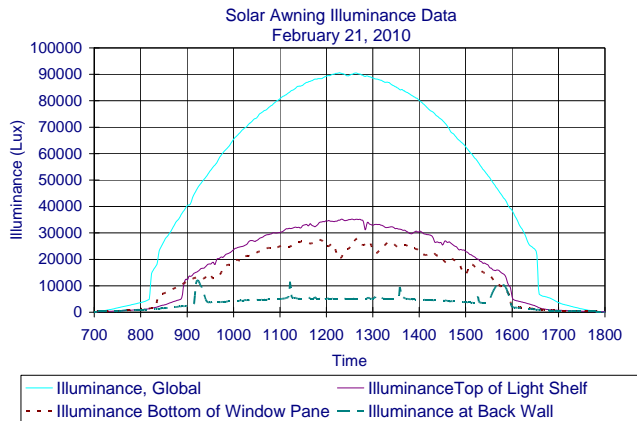
Fig. 16: Illuminance measurements on a clear day. Top solid line is on the light shelf outside the window. Second solid line is on the light shelf in the hallway. Dotted line is on the bottom window frame in the hallway. Dashed line is from the horizontal instrument on the back wall.

A sample of the illuminance readings on a clear day in February is shown in Fig. 16. There is a significant difference between the illuminance inside and outside the window because of the film on the window to reduce heat loss. The illuminance is down by a factor of nearly 3. The roughness of the illuminance on the bottom of the window sill results from shading by trees or other objects. The illuminance measured on the back wall is reduced by a factor of nearly 7. The spikes in the data from the back wall result from the light passing between gaps in the light shelf. Fig. 2 shows the pattern of the gaps that can move up and down or across the back wall as the sun moves across the sky.

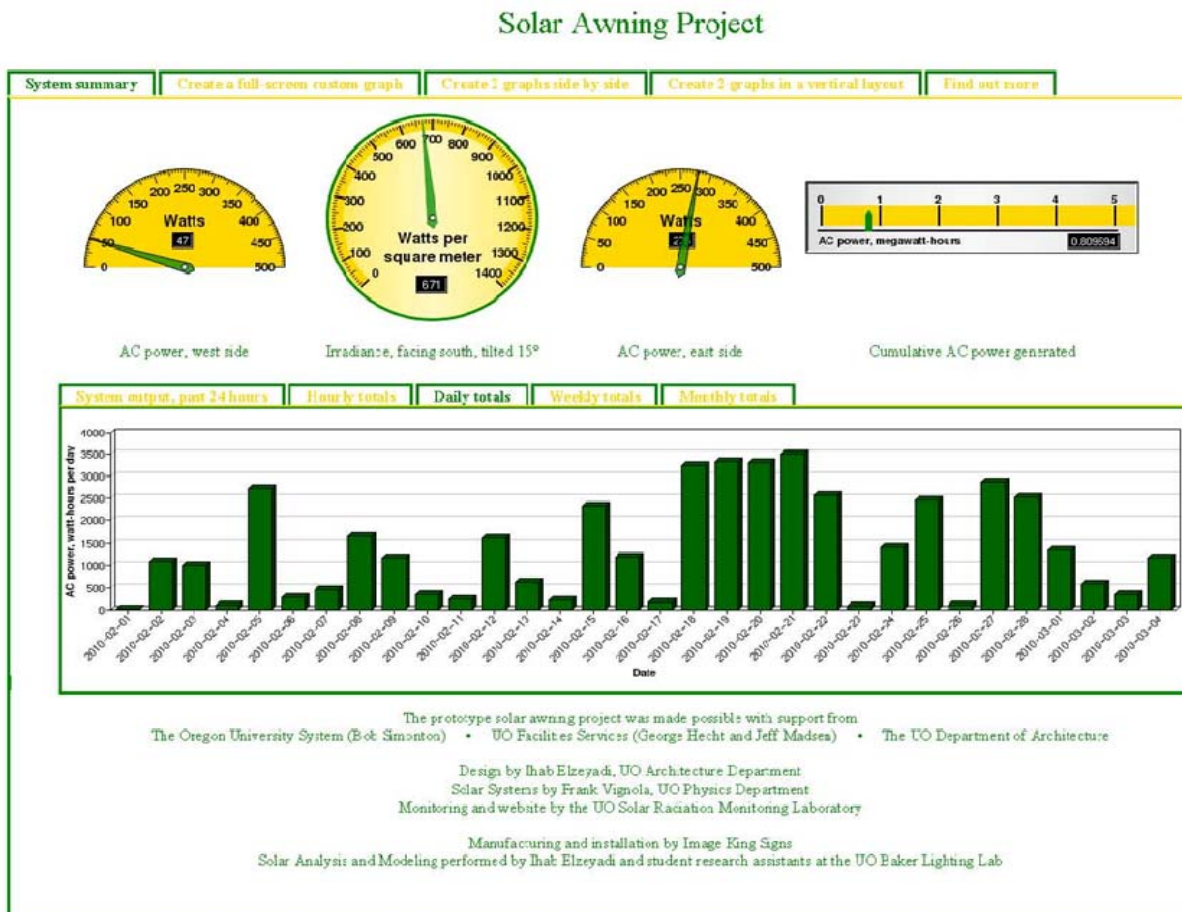
Fig. 17: Display on kiosk's home page. Meters for instantaneous display are on the top row along with one showing the cumulative AC output. Plots of one-minute, hourly, daily, weekly, and monthly AC output can be chosen by selecting taps above the plot. Example is for daily totals.

The interactive kiosk display is designed to be used by students who will conduct measurements and tests of the performance of the solar awning. While this is a learning tool for classes studying the solar awning, it is also used to showcase the solar awning and to familiarize students, faculty, and staff about an actual energy component of the building and get them interested in building energy use. At the top of the display are graphic meters that show the instantaneous output of the arrays and incident solar radiation. The total amount of energy produced is also displayed (Fig. 17).

A graph of the AC power produced is also shown in the display below the gauges (Fig. 17). Tabs allow views of AC power minute by minute, hourly, daily, weekly, and monthly. The data are updated every minute. Other pages, yet to be constructed, will enable those at the kiosk to view the readings of the other instruments. Another page will allow the view to select between a combination of measurements and compare and contrast the results. The final page discusses the project.
